# BOURLAND TRESTLE HISTORIC PRESERVATION OPTIONS

HISTORIC PRESERVATION OPTIONS  
FOR THE

BOURLAND TRESTLE  
IN THE  
STANISLAUS NATIONAL  
FOREST

January 5, 2000

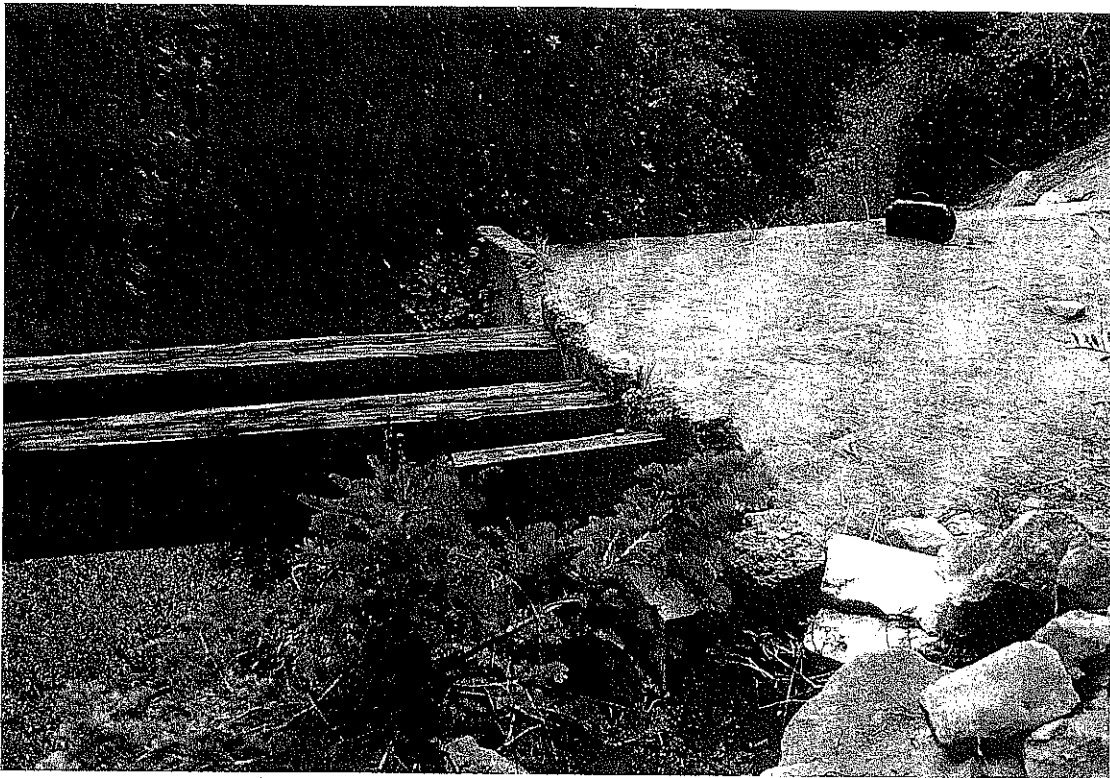
Landing @ # 0

Concrete is in good shape but the ledger needs some repairing.

5.0	REMOVE STREAMBED FOOTINGS	1	LS	\$11,250.00	\$11,250
6.0	<b>SUBTOTAL</b>				<b>\$173,250</b>
7.0					
8.0	<b>LANDING @ #0</b>				
9.0	REPAIR LEDGER	1	LS	\$750.00	\$750

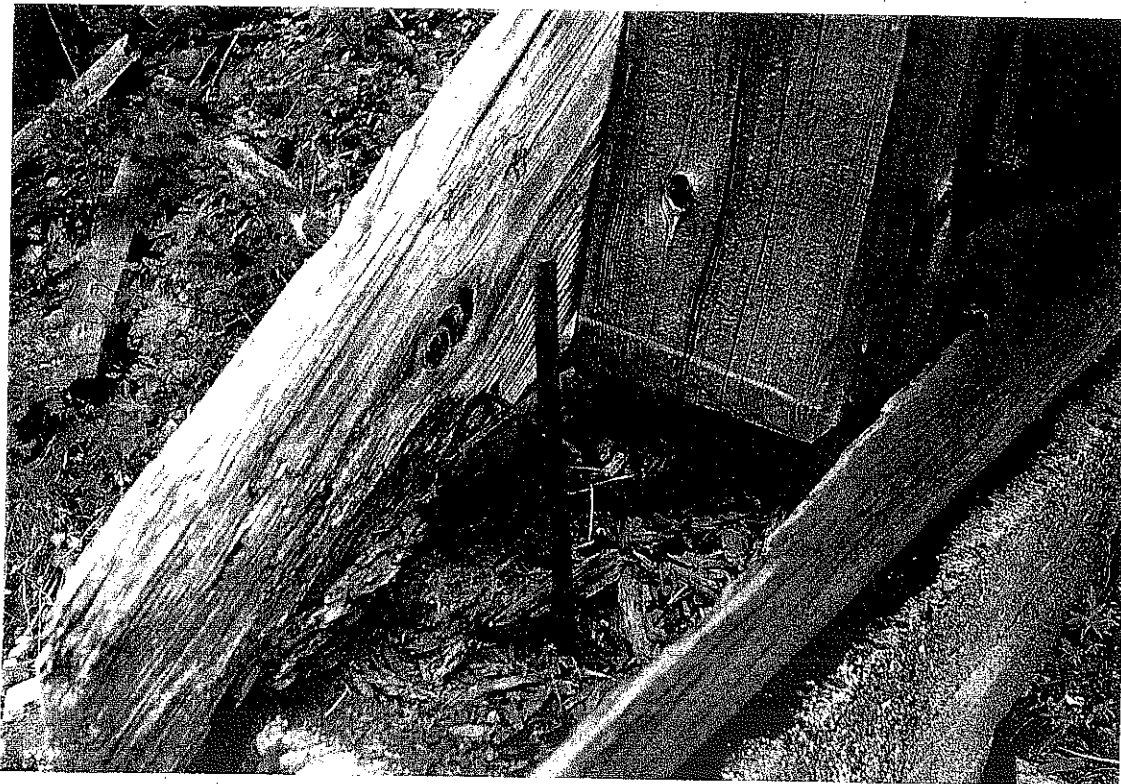
Sill dry rot with bolt coming through,  
not holding anything anymore

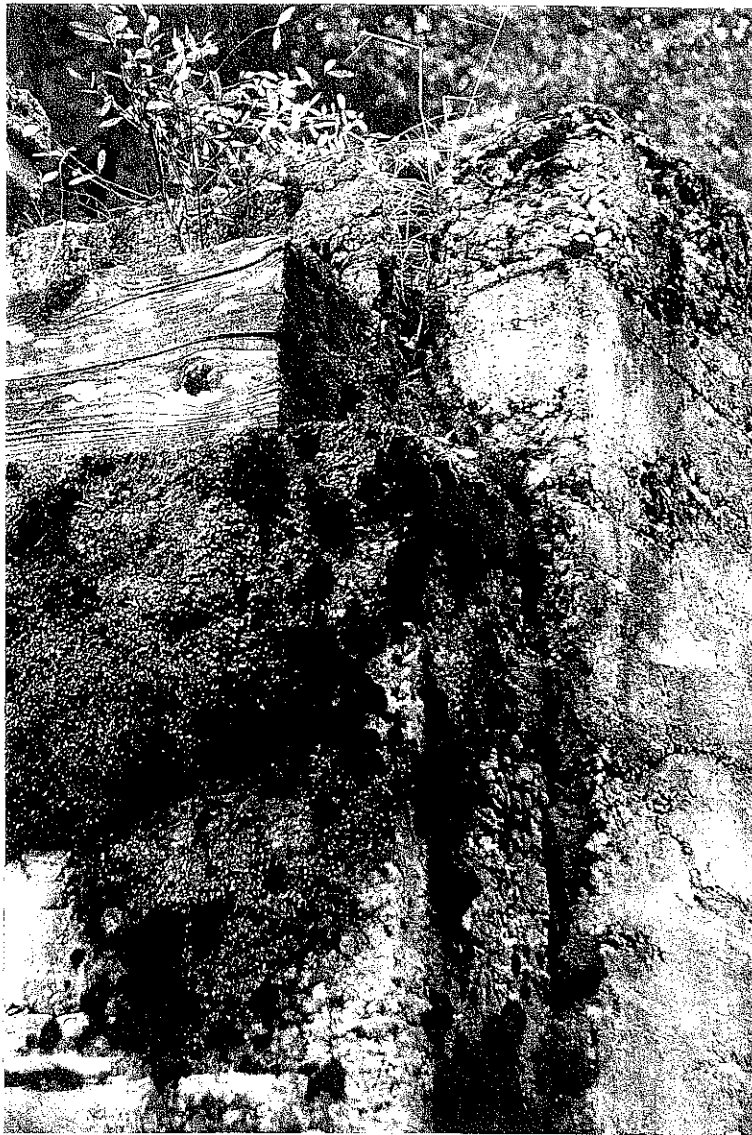
Landing @ # 23 shows vertical crack in concrete

The cap is dry rotted and crushing and must be replaced. The #4 and #6 Stringers are gone and must be reinstalled. Stringers #1, #2, #3 and #5 are all fixable. The concrete landing wall has a vertical crack at the connection on the downstream side of the two perpendicular concrete walls. It should be reevaluated. (Stringers from Bent #22 to the landing at #23).

172.0	REPAIR DRY ROT / DAMAGE	4	LOC	\$525.00	\$2,100
173.0	GROUT CONCRETE WALL	1	LS	\$262.50	\$263
174.0	REPAIR / REPLACE STRUCTURAL HARDWARE	1	LS	\$225.00	\$225

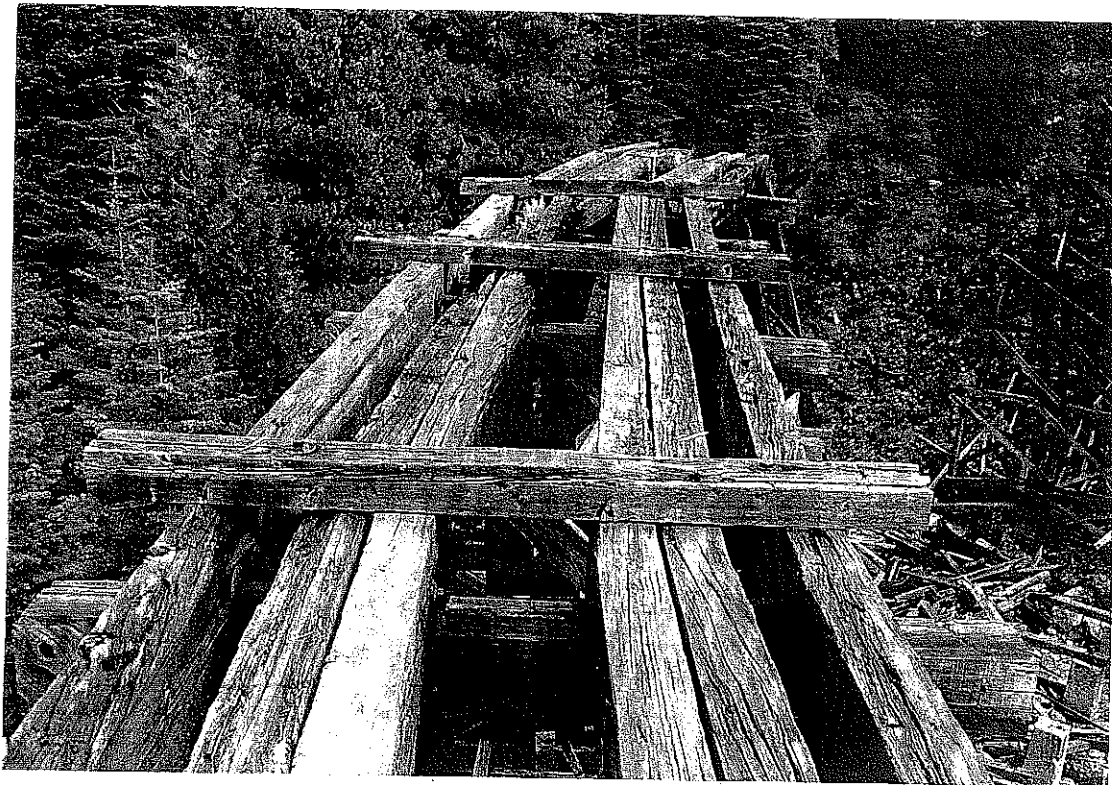
Dry rot shown on tops of stringers,  
heavy damage shown on stringer #1

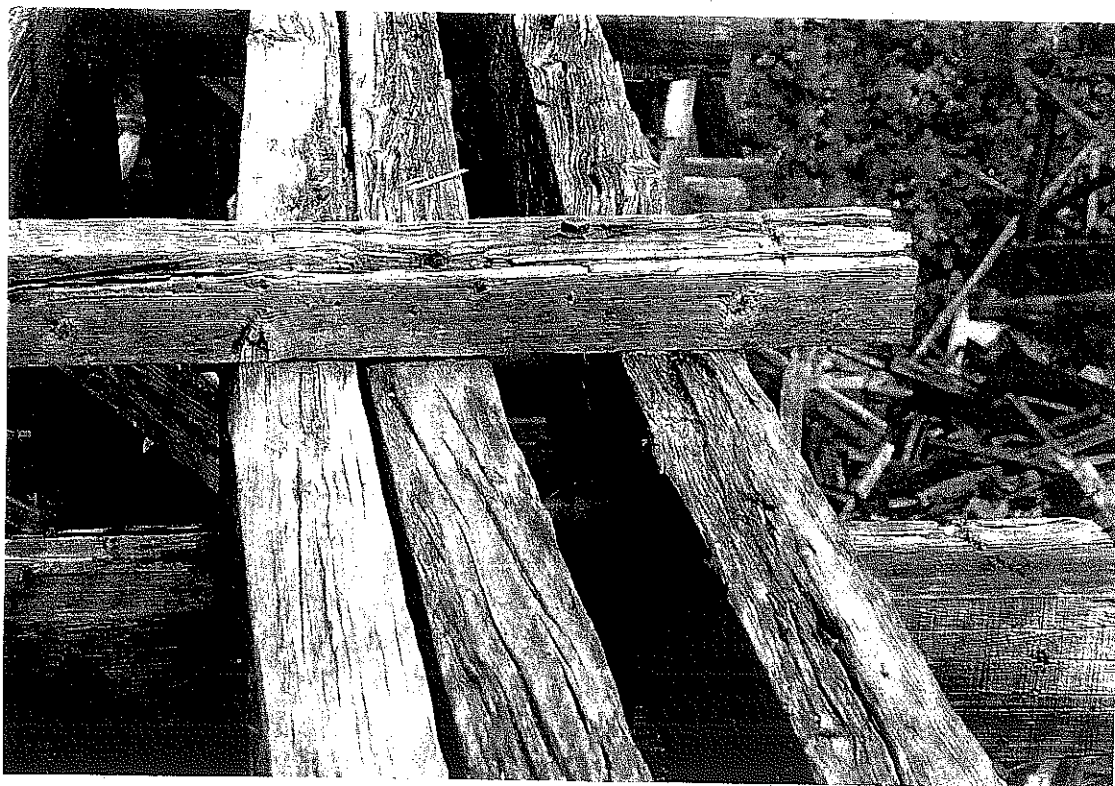
Railroad tie showing some damage and cast iron  
hardware between the stringers

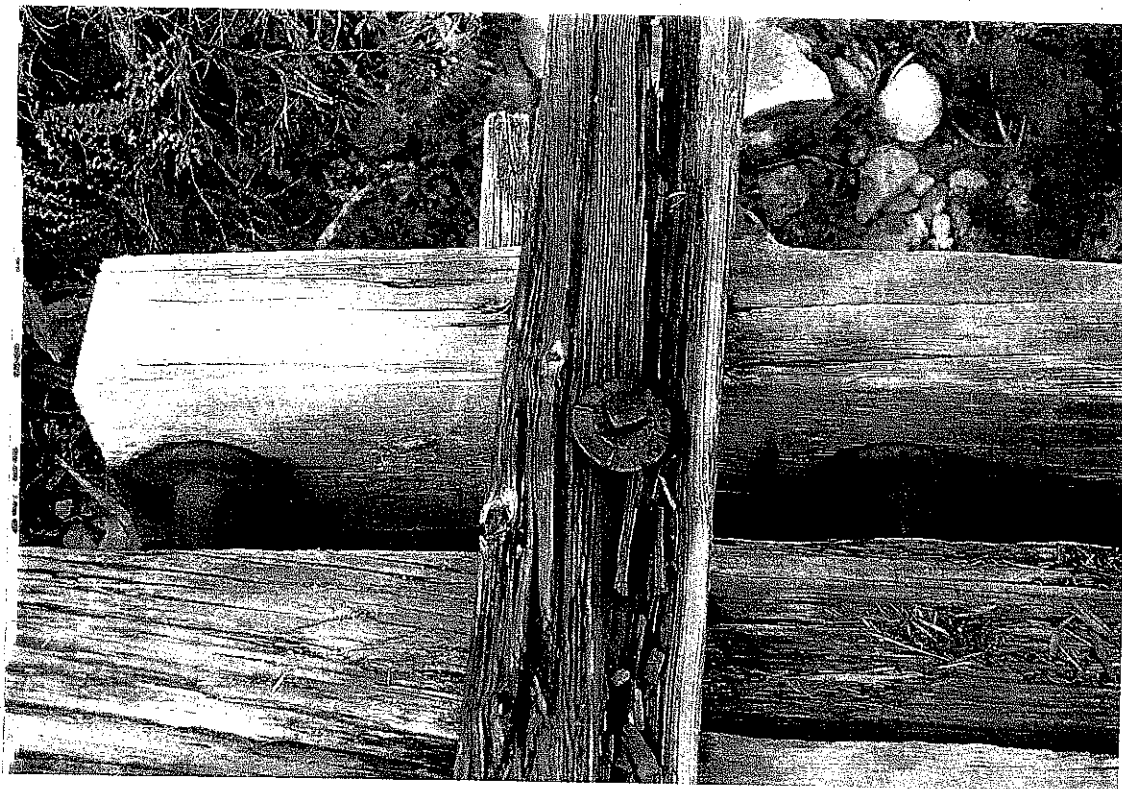
Dry rot, cast iron hardware, and bolted connection
